Summary of EPA Surface Water Sampling of Select Metals
Results to Date
Gold King Mine Blowout

August 7, 2015

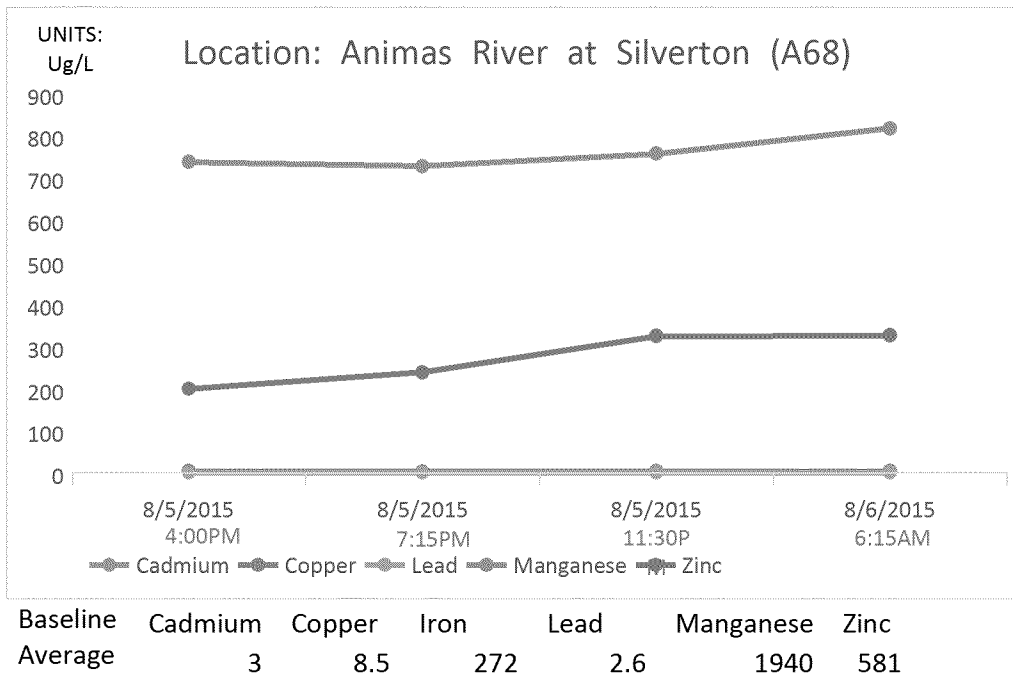
The second graph provides data on the Animas River above the town of Silverton (A68) and above Cement Creek. This graph demonstrates relatively unchanging metals concentrations that are at or below historical averages.

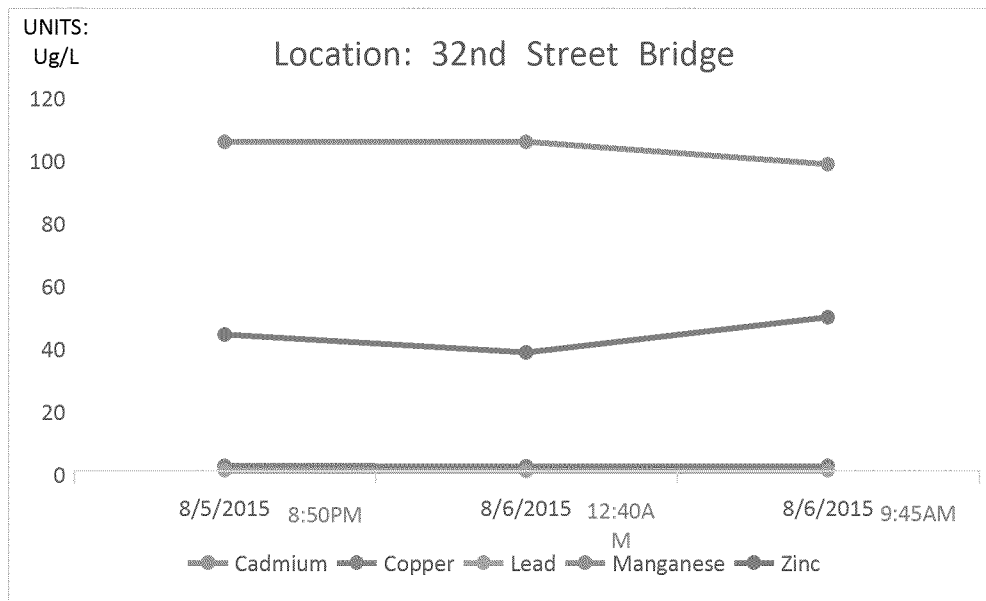
The fifth graph is of the 32nd Street Bridge sampling location. At the time the samples were collected, it does not appear that the contamination had yet reached this sampling location.
